Proper Gasket Selection Helps Maximize Tank Service Life

by Steve Benet & Richie Richardson

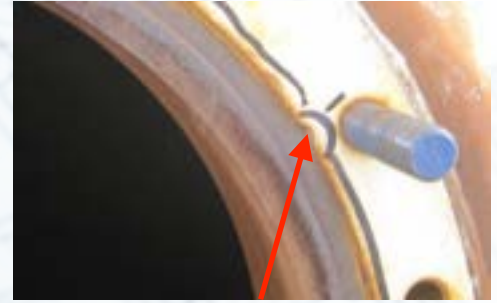
Broad Surface Corrosion (HF Acid Tank)

Many products transported in ISO tanks need to be tightly sealed or their fugitive emissions (small leaks that cannot be detected by bubble leak testing) can cause corrosion damage to the sealing surfaces that requires costly repairs. These repairs are costly and take tanks out of dedicated service prematurely. Pictures show examples of this corrosion damage on HF and refrigerant tank manways sealed with spiral wound gaskets. Most refrigerant and HF gas leaks/emissions from manways and other tank connections, form hydrofluoric acid droplets when exposed to a moist atmosphere. These droplets accumulate to form pitting and broad surface corrosion on the flange surfaces as seen in the pictures of these two tanks.

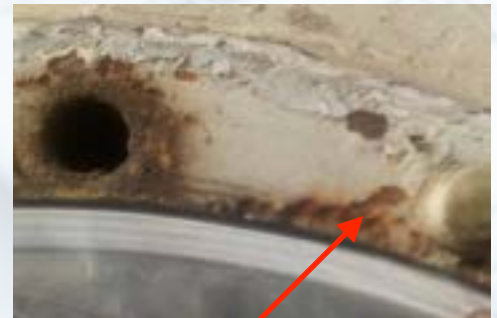
Droplet/Pitting Corrosion (Refrigerant Tank)

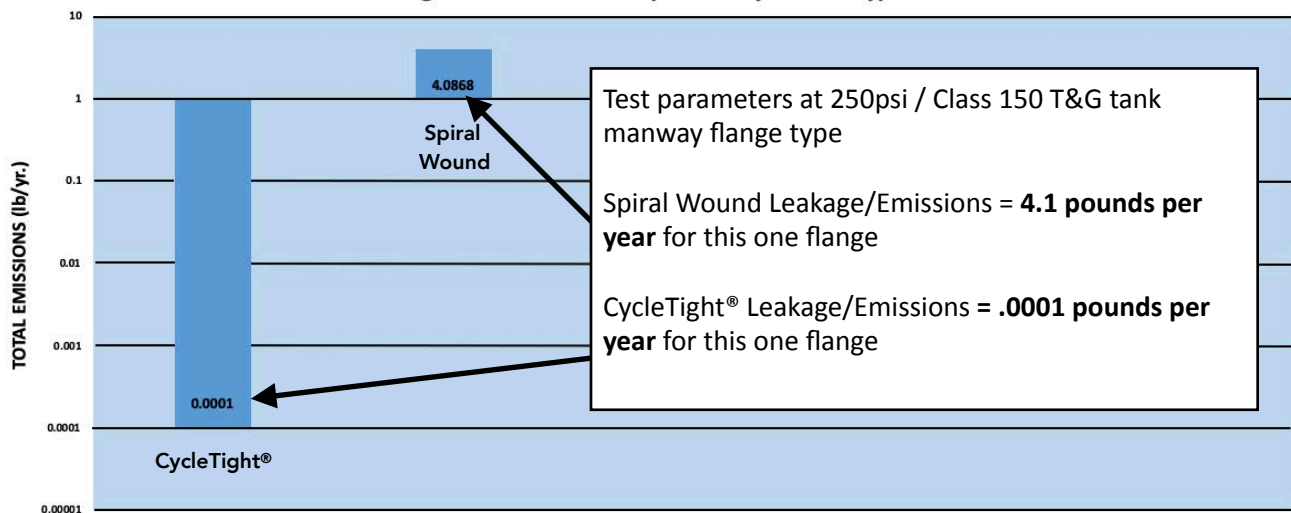
Fugitive Emissions Comparison By Gasket Type

In the past, before this emissions/leakage/corrosion mechanism was well understood, spiral wound gaskets were typically used for these T&G manway connections. Shippers and Leasing Companies just accepted this leakage/corrosion damage as another "cost of doing business". These are costly repairs for the Shippers and Leasing Companies, all because they're unknowingly using an inexpensive, "leaky" gasket. In order to prevent this corrosion and expensive repairs, 20 years ago VSP Technologies developed CycleTight® gasket technology which provides a significantly tighter seal utilizing the same bolt load/torque. The result is T4/T5 Tightness performance versus T2/T3 Tightness performance associated with traditional spiral wound gaskets. That's 40,000X lower leakage/emissions with the CycleTight® gasket!
